# Surface casing corrosion Grane platform wells

Annette Pihl Pettersen, Equinor

## Finding - Severe corrosion on surface casing on two wells

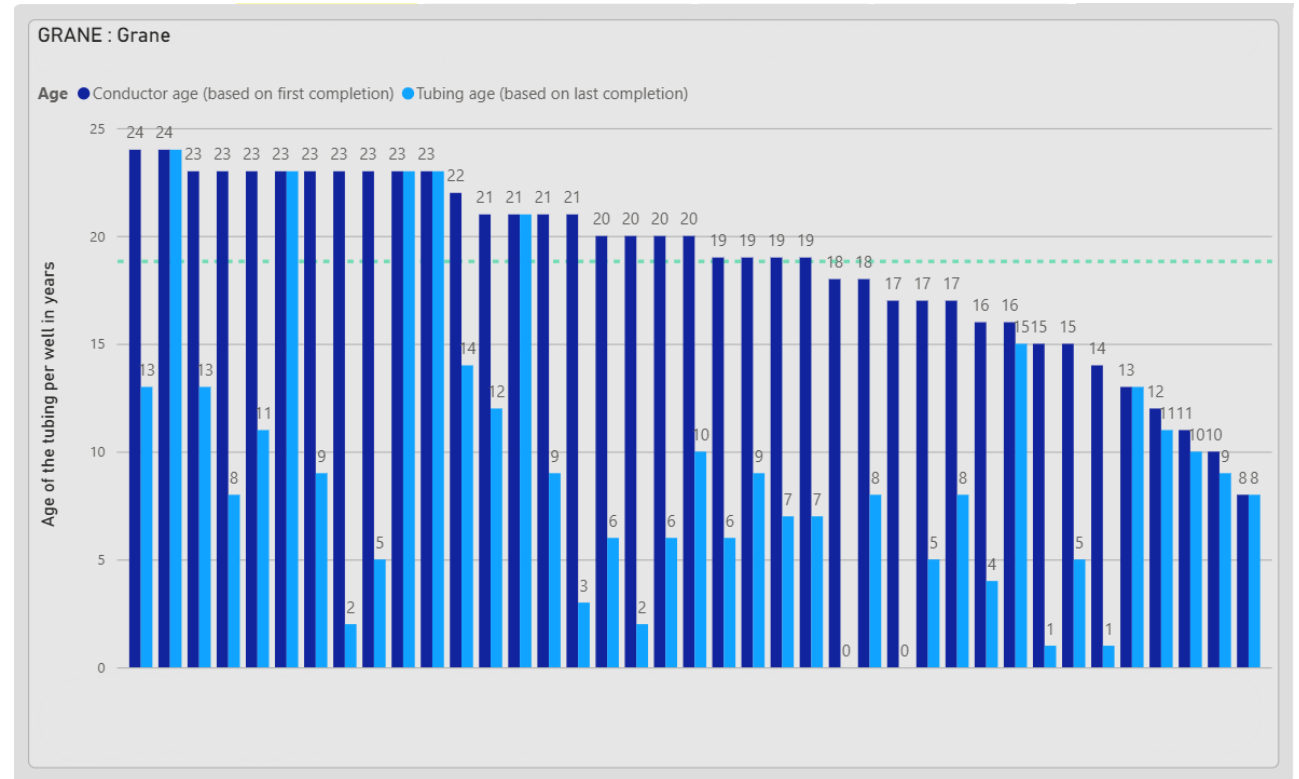
Grane platform wells age profile

- Well design life 30 years
- Oldest wells: 24 years
- Youngest wells: 8 years
- 28" conductor 19.05mm wall thickness
- 18 5/8" surface casing 11,05 mm wall thickness

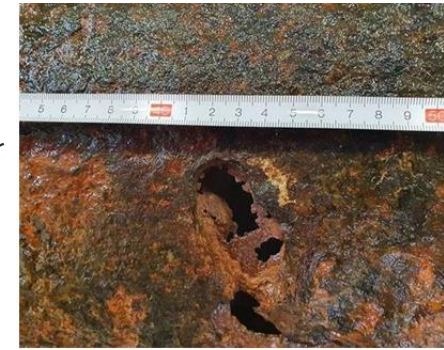
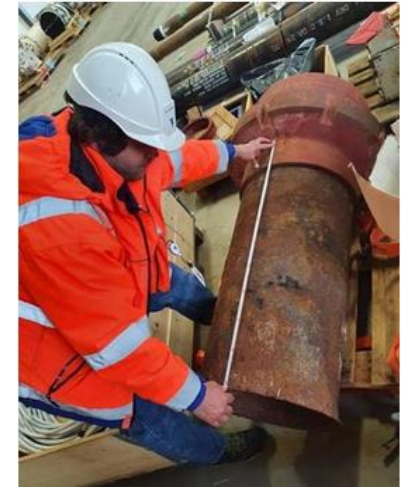
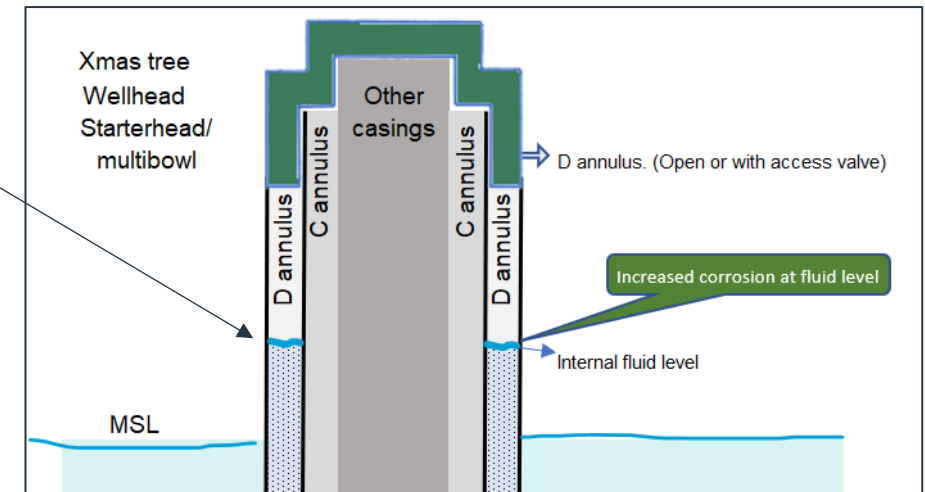
- Logged surface casing and found severe corrosion 0,5m below casing hanger
- The surface casing was cut and pulled 1 m below hanger on both wells
  - 16" surface casing and new 18 5/8" wellhead was run
- The location corresponded with liquid level in D annulus
- Correspondence with corrosion inside conductor/outside surface casing.
- The wells were 16 and 12 years at the time
- Actual lifetime of surface casing < design life

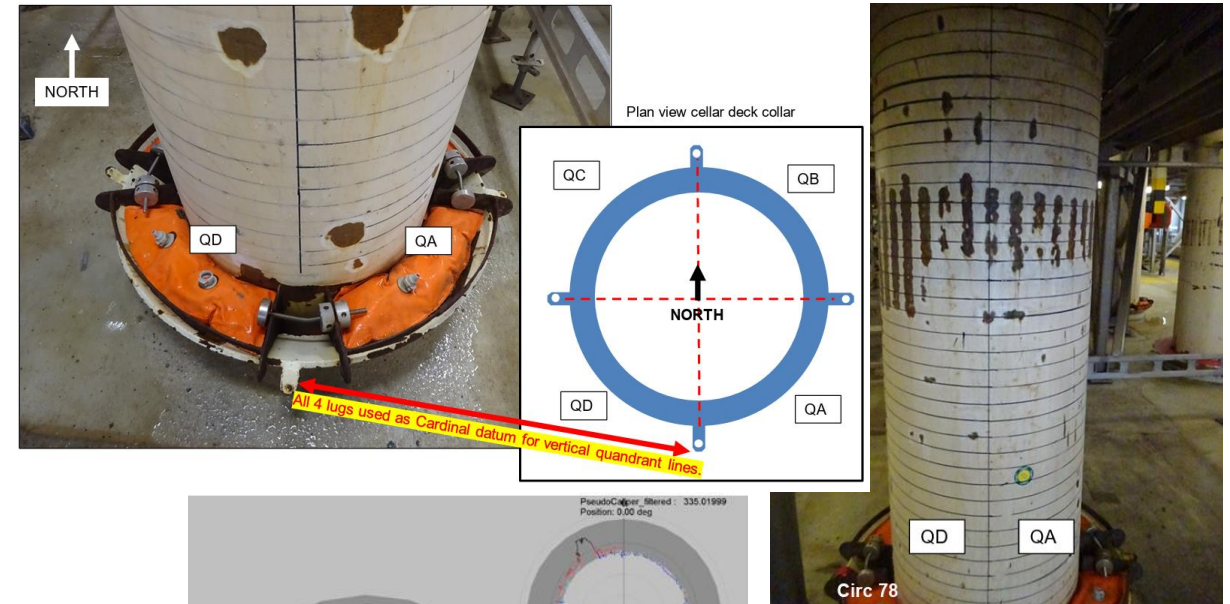
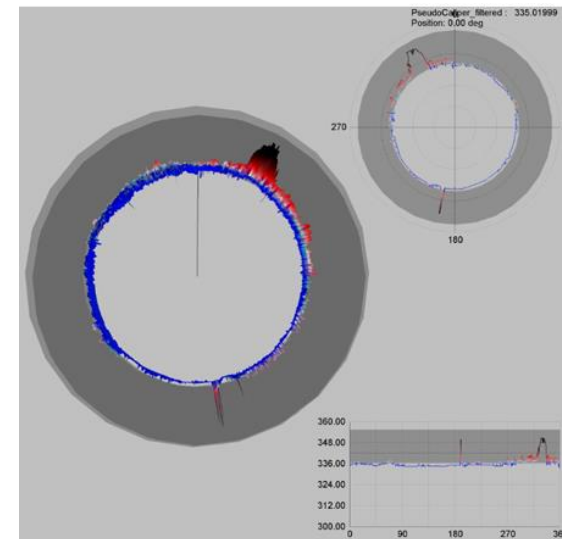
Mapping of sectors/grid when logging with phased array

- Pitting: - WT reduced from 19mm to 4 mm.
- Overall cross-sectional corrosion: - Minor.

- Air vs liquid level
- Bacterial
- Inhibitive liquid vs non inhibitive liquid

Pitting and cross sectional corrosion on worst case well

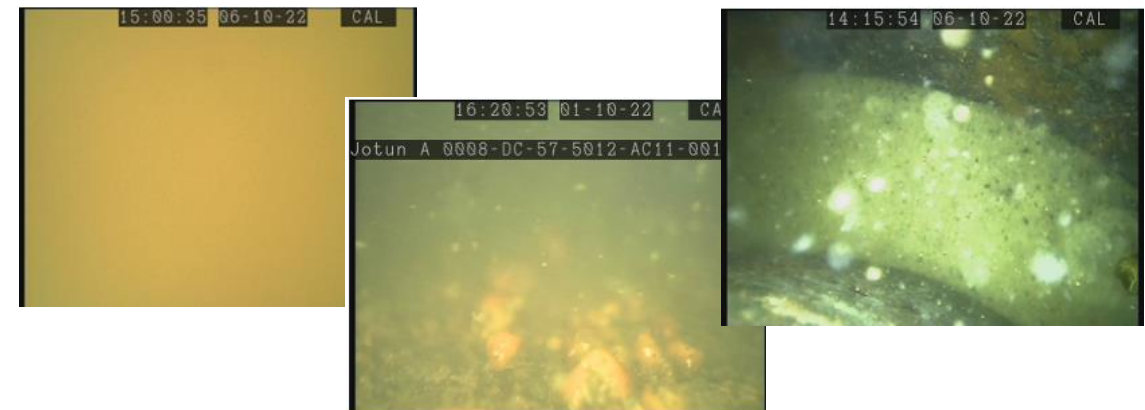
Camera inspections (pictures from 3 different wells)

- Limited access
- Algae growth
- Clouded liquid
- Hung up on cement patches

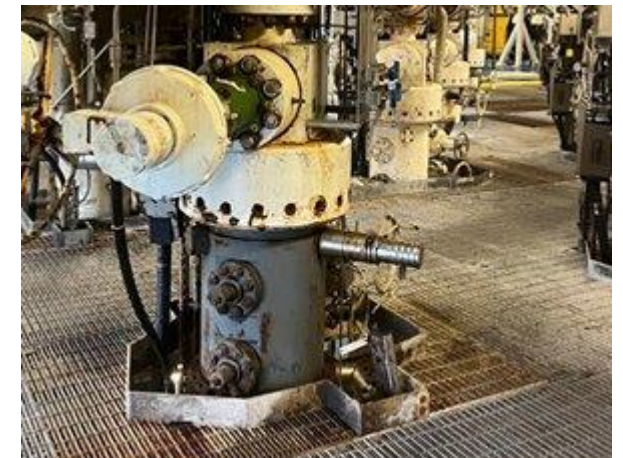
- Result – Minimum required average circumferential wall thickness 9mm

### **Buckling – Result very dependant on cement in annuli. (conductor).**

- Result – Uncemented - Minimum required average circumferential wall thickness 15mm
- Result cemented - Minimum required average circumferential wall thickness 8,6mm
