From Risk to Resilience: The critical importance of liquid-filled annuli

Liquid Filled Annuli

**Christer Andresen
Well Integrity Engineer**

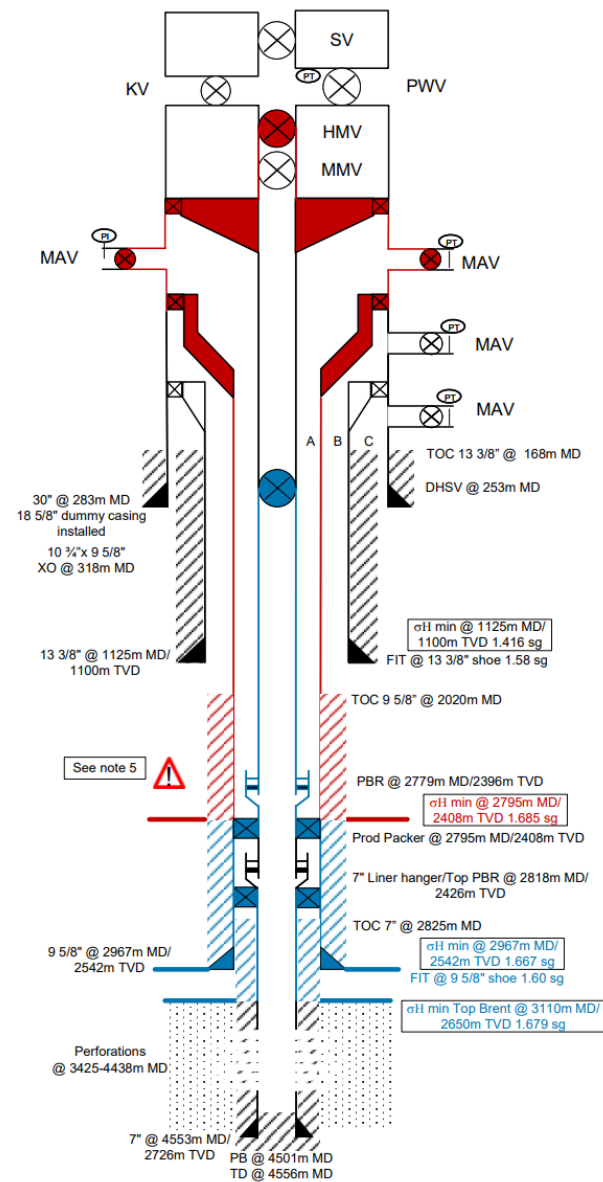
- Oil/gas producer since 1993.
 - +30 years old
 - Most important producer on the installation.
- None failed/FOF PM tests last 12M.
- Positive pressure on all annuli.
 - Nitrogen used to pressurize.
- Stabile well – No verification of liquid filled annuli performed for many years.
- Green integrity status.
 - Primary and secondary barrier intact.

Well barrier elements	WBEAC tables	Verification	Monitoring						
PRIMARY									
Formation at Cap rock	51	σH min 1.679 sg. Method: ref see Note 4.	n/a after initial verification						
7" Liner cement	22	Length: 285m MD > Cap rock Method: see Note 1.	n/a after initial verification						
7" Liner	2	PT: 280 bar with 1.21 sg (DBR 16.04.1993)	n/a after initial verification						
7" Liner hanger packer	43	PT: 280 bar with 1.21 sg (DBR 16.04.1993)	n/a after initial verification						
Formation at 9 5/8" casing shoe	55	FIT: 1.60 sg EMW. (DBR 29.03.1993)	n/a after initial verification						
9 5/8" Production casing cement (up to prod packer)	22	Length: 172m MD > shoe Method: see Note 2.	n/a after initial verification						
9 5/8" Production casing (up to prod packer)	2	PT: 280 bar with 1.52 sg (DBR 27.03.1993)	n/a after initial verification						
Production packer	7	PT: 280 bar with 1.06 sg (DBR 21.04.1993)	Continuous pressure monitoring of A-annulus

Production tubing (w/ PBR)	25 (29)	PT: 280 bar with 1.06 sg (DBR 21.04.1993)	Continuous pressure monitoring of A-annulus						
DHSV Control line	8	IT: 27 bar (DBR 21.04.1993) PT: 570 bar (DBR 21.04.1993)	Periodic leak testing. AC: Max 3.2 bar/30 min						
SECONDARY									
Formation at Prod packer	51	σH min 1.685 sg. Method: ref see Note 4.	n/a after initial verification						
9 5/8" Production casing cement (above packer)	22	Length: 700m MD > packer Method: see Note 2.	n/a after initial verification						
10 3/4" x 9 5/8" Production casing (above packer)	2	PT: 280 bar with 1.52 sg (DBR 27.03.1993)	Continuous pressure monitoring of B-annulus						
10 3/4" Casing hanger with seal assembly	5	PT: 280 bar with 1.52 sg (DBR 27.03.1993)	Continuous pressure monitoring of B-annulus						
Tubing hanger with seals	10	PT: 280 bar with 1.06 sg (DBR 21.04.1993)	Continuous pressure monitoring of A-annulus/ Periodic leak testing

WH/A-annulus access valve	12	PT: xxx bar (DBR xx.xx.1993)	Periodic testing of valve AC: Max 10 % of annulus pressure bar/10 min.						
Tubing hanger neck seal	33	PT: 345 bar (FWR 22.04.1993)	Periodic leak testing						
X-mas tree connector	33	PT: 345 bar (FWR 22.04.1993)	Periodic leak testing						
X-mas tree valves	33	PT: 345 bar (FWR 19.04.1993)	Periodic testing of valve AC: Max 10 % of test pressure bar/10 min.						
Notes:

1. 7" TOC at LH depth: single barrier for operation phase considered "intact". Pumped 34 m3, lost 4,5 m3 (15% loss), cement to top liner. Cement shall be evaluated during next re-entry.

2. 9 5/8" cement: re-evaluated old CBL log which indicate potentially good cement intervals above packer of 18 and 48 m (report not uploaded to DBR, but available on teamsite). Two independent cement jobs acting as a barrier against reservoir.

3. 13 3/8" TOC: Ref Hydro FWR, well drawing 3.1. TOC up to cellardeck, 18 5/8" dummy casing installed.									
4. Sh calibrated by XLOT, minifrac, mudloss B and vE Mohr (2010).

5. PBR part of primary barrier, but status is continuously monitored.									
Well Risk Status Code (marked X): Detailed information in iWIT									
<table border="1"> <tr> <td>Well Risk Status Code</td> <td>Green</td> <td>Yellow</td> <td>Orange</td> <td>Red</td> <td>X</td> </tr> </table>				Well Risk Status Code	Green	Yellow	Orange	Red	X
Well Risk Status Code	Green	Yellow	Orange	Red	X				
<table border="1"> <tr> <td>Open Dispensations</td> <td>Comment</td> </tr> <tr> <td>Closed Dispensations - Still Valid</td> <td>Comment</td> </tr> </table>				Open Dispensations	Comment	Closed Dispensations - Still Valid	Comment		
Open Dispensations	Comment								
Closed Dispensations - Still Valid	Comment

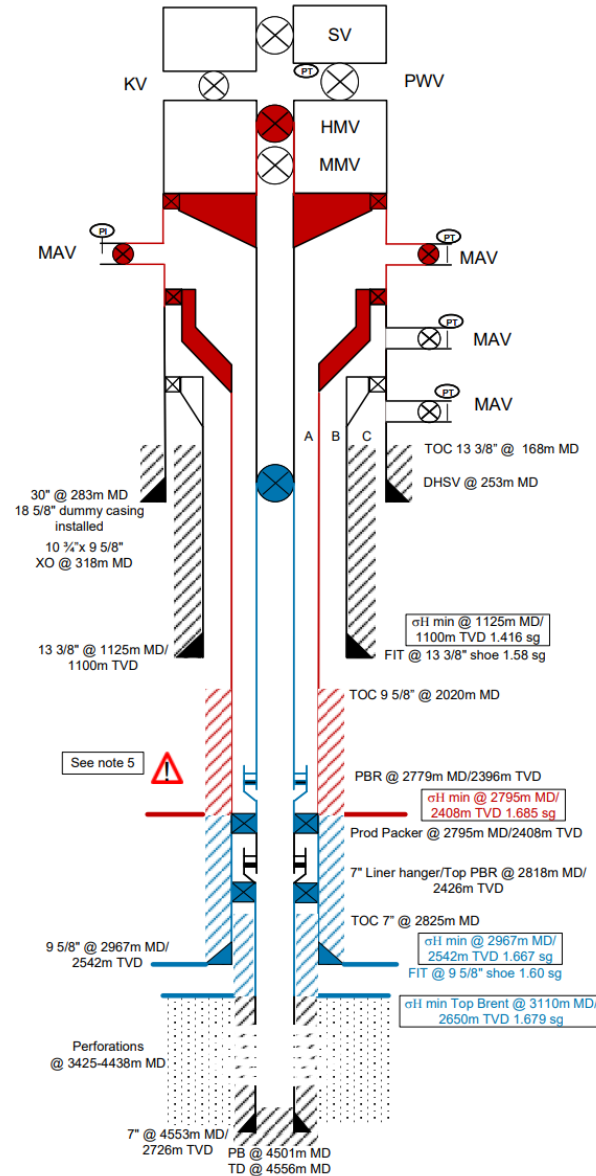
- Well has all barriers intact and positive pressure on annuli.
 - Is it important to do a verification if annuli is liquid filled?
 - Is it important to pressure trend?

Well barrier elements	WBEAC tables	Verification	Monitoring
PRIMARY			
Formation at Cap rock	51	σ_H min 1.679 sg. Method: ref see Note 4.	n/a after initial verification
7" Liner cement	22	Length: 285m MD > Cap rock Method: see Note 1.	n/a after initial verification
7" Liner	2	PT: 280 bar with 1.21 sg (DBR 16.04.1993)	n/a after initial verification
7" Liner hanger packer	43	PT: 280 bar with 1.21 sg (DBR 16.04.1993)	n/a after initial verification
Formation at 9 5/8" casing shoe	55	FIT: 1.60 sg EMW. (DBR 29.03.1993)	n/a after initial verification
9 5/8" Production casing cement (up to prod packer)	22	Length: 172m MD > shoe Method: see Note 2.	n/a after initial verification
9 5/8" Production casing (up to prod packer)	2	PT: 280 bar with 1.52 sg (DBR 27.03.1993)	n/a after initial verification
Production packer	7	PT: 280 bar with 1.06 sg (DBR 21.04.1993)	Continuous pressure monitoring of A-annulus
Production tubing (w/ PBR)	25 (29)	PT: 280 bar with 1.06 sg (DBR 21.04.1993)	Continuous pressure monitoring of A-annulus

DHSV Control line	8	IT: 27 bar (DBR 21.04.1993) PT: 570 bar (DBR 21.04.1993)	Periodic leak testing. AC: Max 3.2 bar/30 min
SECONDARY			
Formation at Prod packer	51	σ_H min 1.685 sg. Method: ref see Note 4.	n/a after initial verification
9 5/8" Production casing cement (above packer)	22	Length: 700m MD > packer Method: see Note 2.	n/a after initial verification
10 3/4" x 9 5/8" Production casing (above packer)	2	PT: 280 bar with 1.52 sg (DBR 27.03.1993)	Continuous pressure monitoring of B-annulus
10 3/4" Casing hanger with seal assembly	5	PT: 280 bar with 1.52 sg (DBR 27.03.1993)	Continuous pressure monitoring of B-annulus
Tubing hanger with seals	10	PT: 280 bar with 1.06 sg (DBR 21.04.1993)	Continuous pressure monitoring of A-annulus/ Periodic leak testing
WH/A-annulus access valve	12	PT: xxx bar (DBR xx.xx.1993)	Periodic testing of valve AC: Max 10 % of annulus pressure bar/10 min.
Tubing hanger neck seal	33	PT: 345 bar (FWR 22.04.1993)	Periodic leak testing

X-mas tree connector	33	PT: 345 bar (FWR 22.04.1993)	Periodic leak testing
X-mas tree valves	33	PT: 345 bar (FWR 19.04.1993)	Periodic testing of valve AC: Max 10 % of test pressure bar/10 min.
Notes:

1. 7" TOC at LH depth: single barrier for operation phase considered "intact". Pumped 34 m3, lost 4,5 m3 (15% loss), cement to top liner. Cement shall be evaluated during next re-entry.

2. 9 5/8" cement: re-evaluated old CBL log which indicate potentially good cement intervals above packer of 18 and 48 m (report not uploaded to DBR, but available on teamsite). Two independent cement jobs acting as a barrier against reservoir.

3. 13 3/8" TOC: Ref Hydro FWR, well drawing 3.1. TOC up to cellardeck, 18 5/8" dummy casing installed.			
4. Sh calibrated by XLOT, minifrac, mudloss B and vE Mohr (2010).

5. PBR part of primary barrier, but status is continuously monitored			
Well Risk Status Code (marked X): Detailed information in iWIT			
A) PBR part of primary barrier			
Open Dispensations	Comment		
Closed Dispensations - Still Valid	Comment

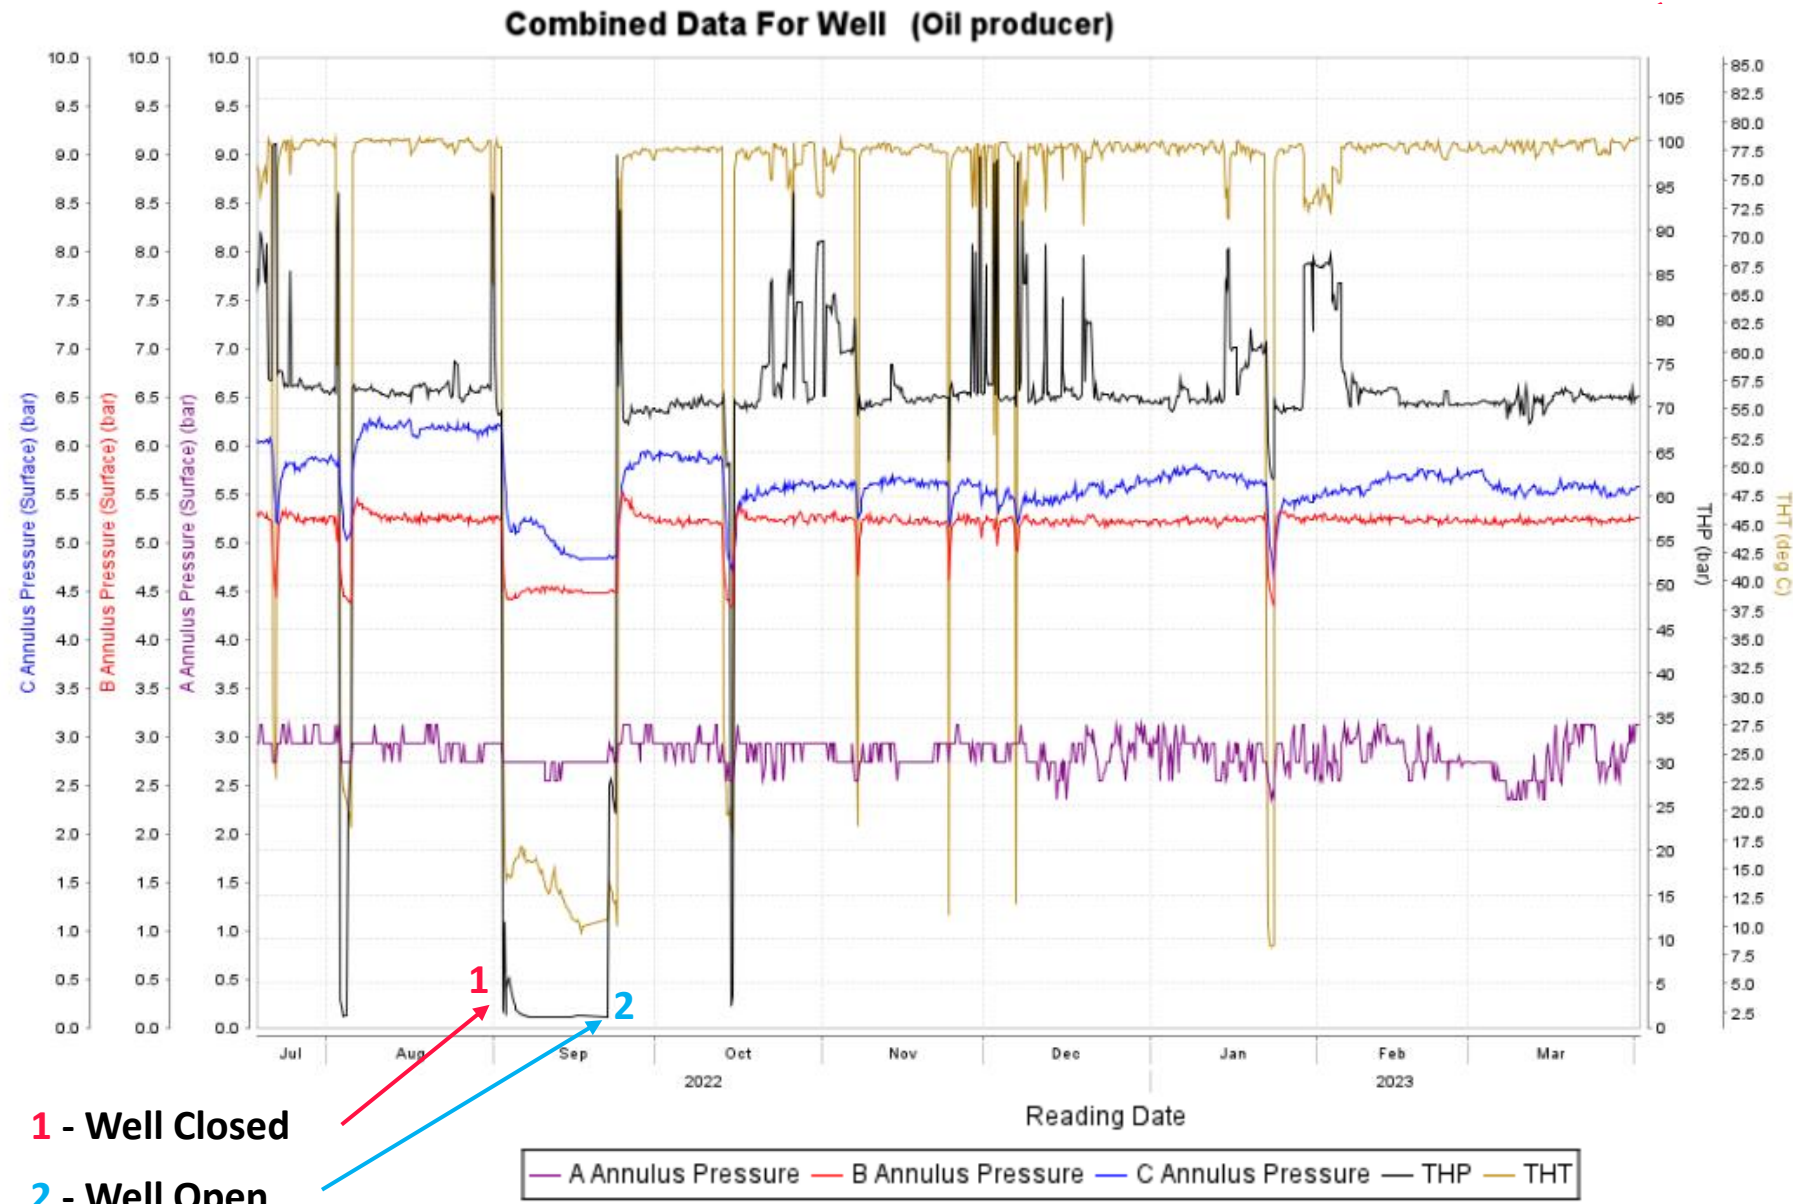
- Trending conducted April 2023.
- Trend history 9 months back in time.

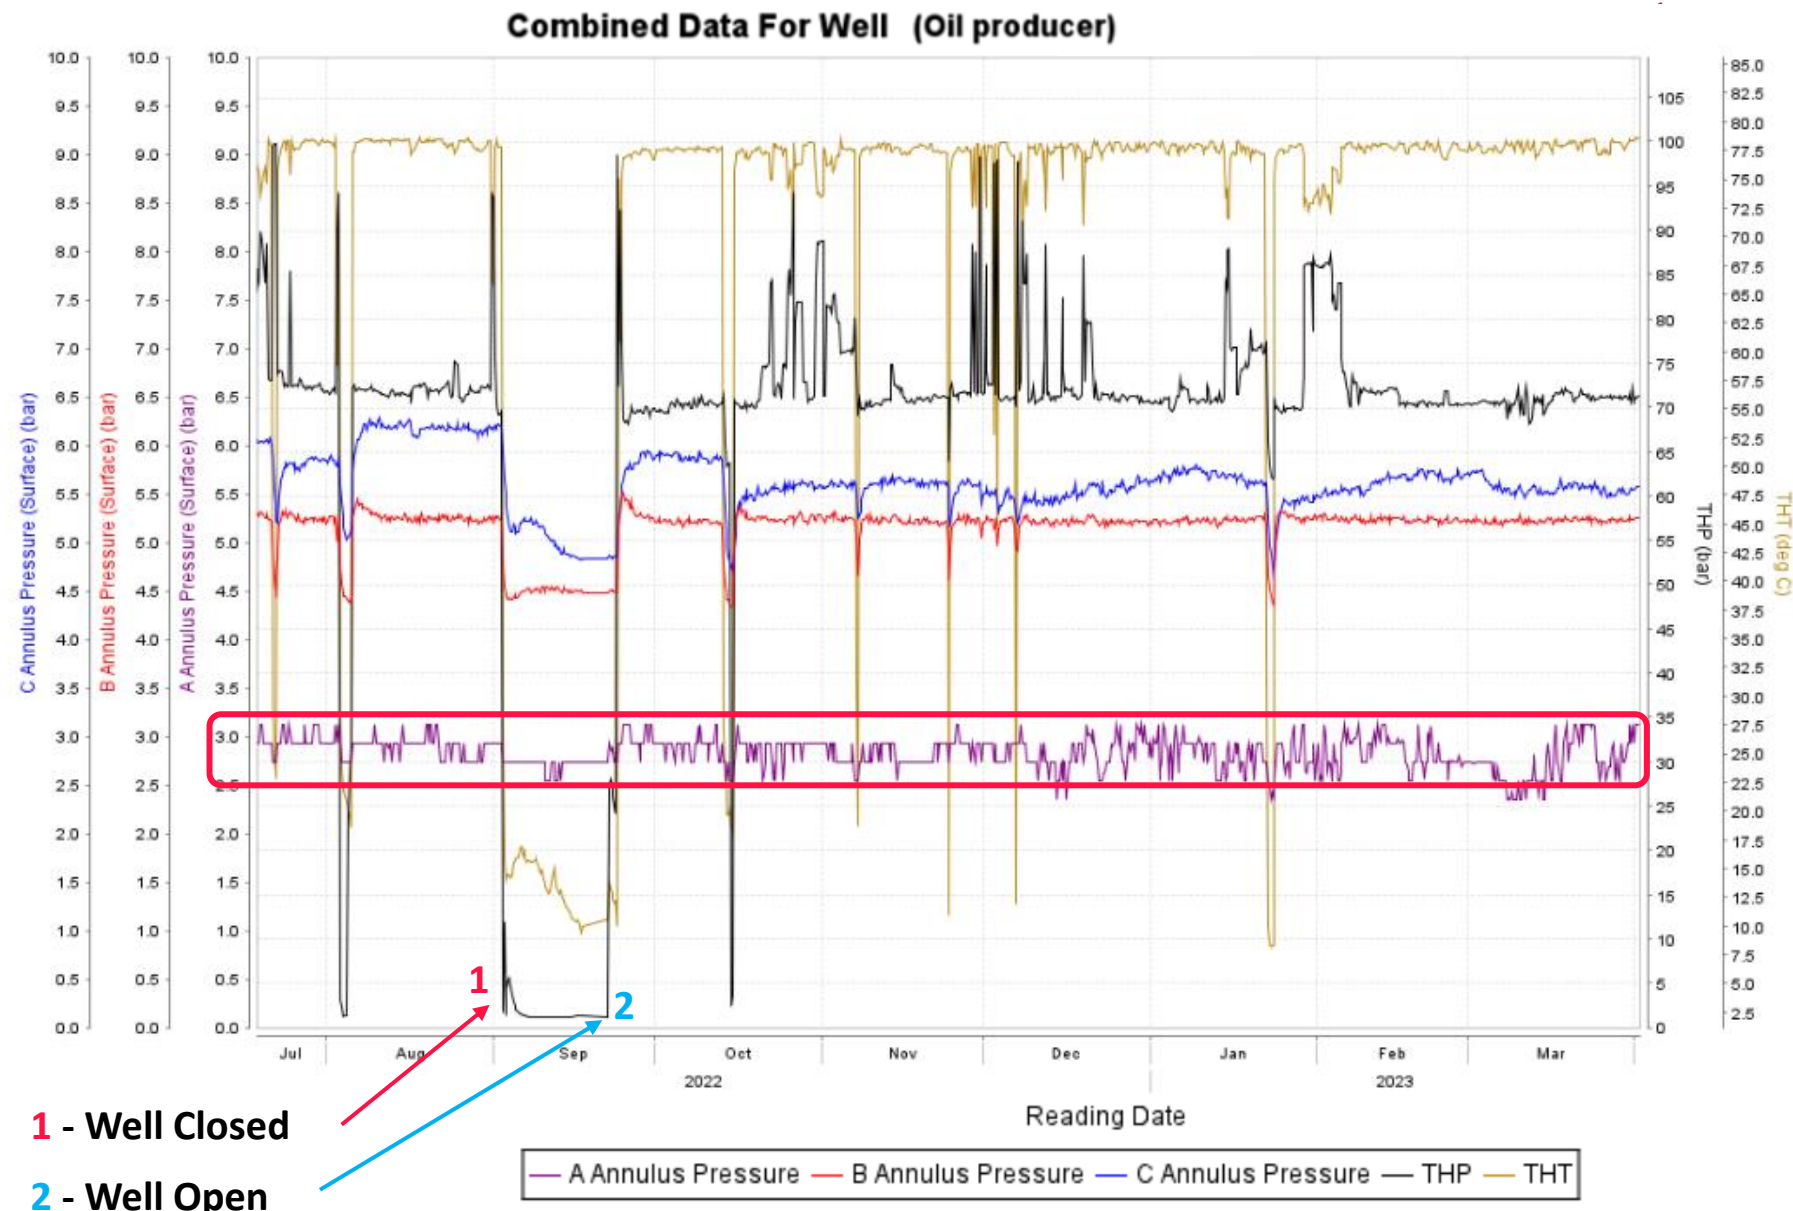
1 - Well Closed
2 - Well Open

- Annulus-A - low and stable pressure for long time.
 - Req. 3 – Use of alarm to monitor well barriers.

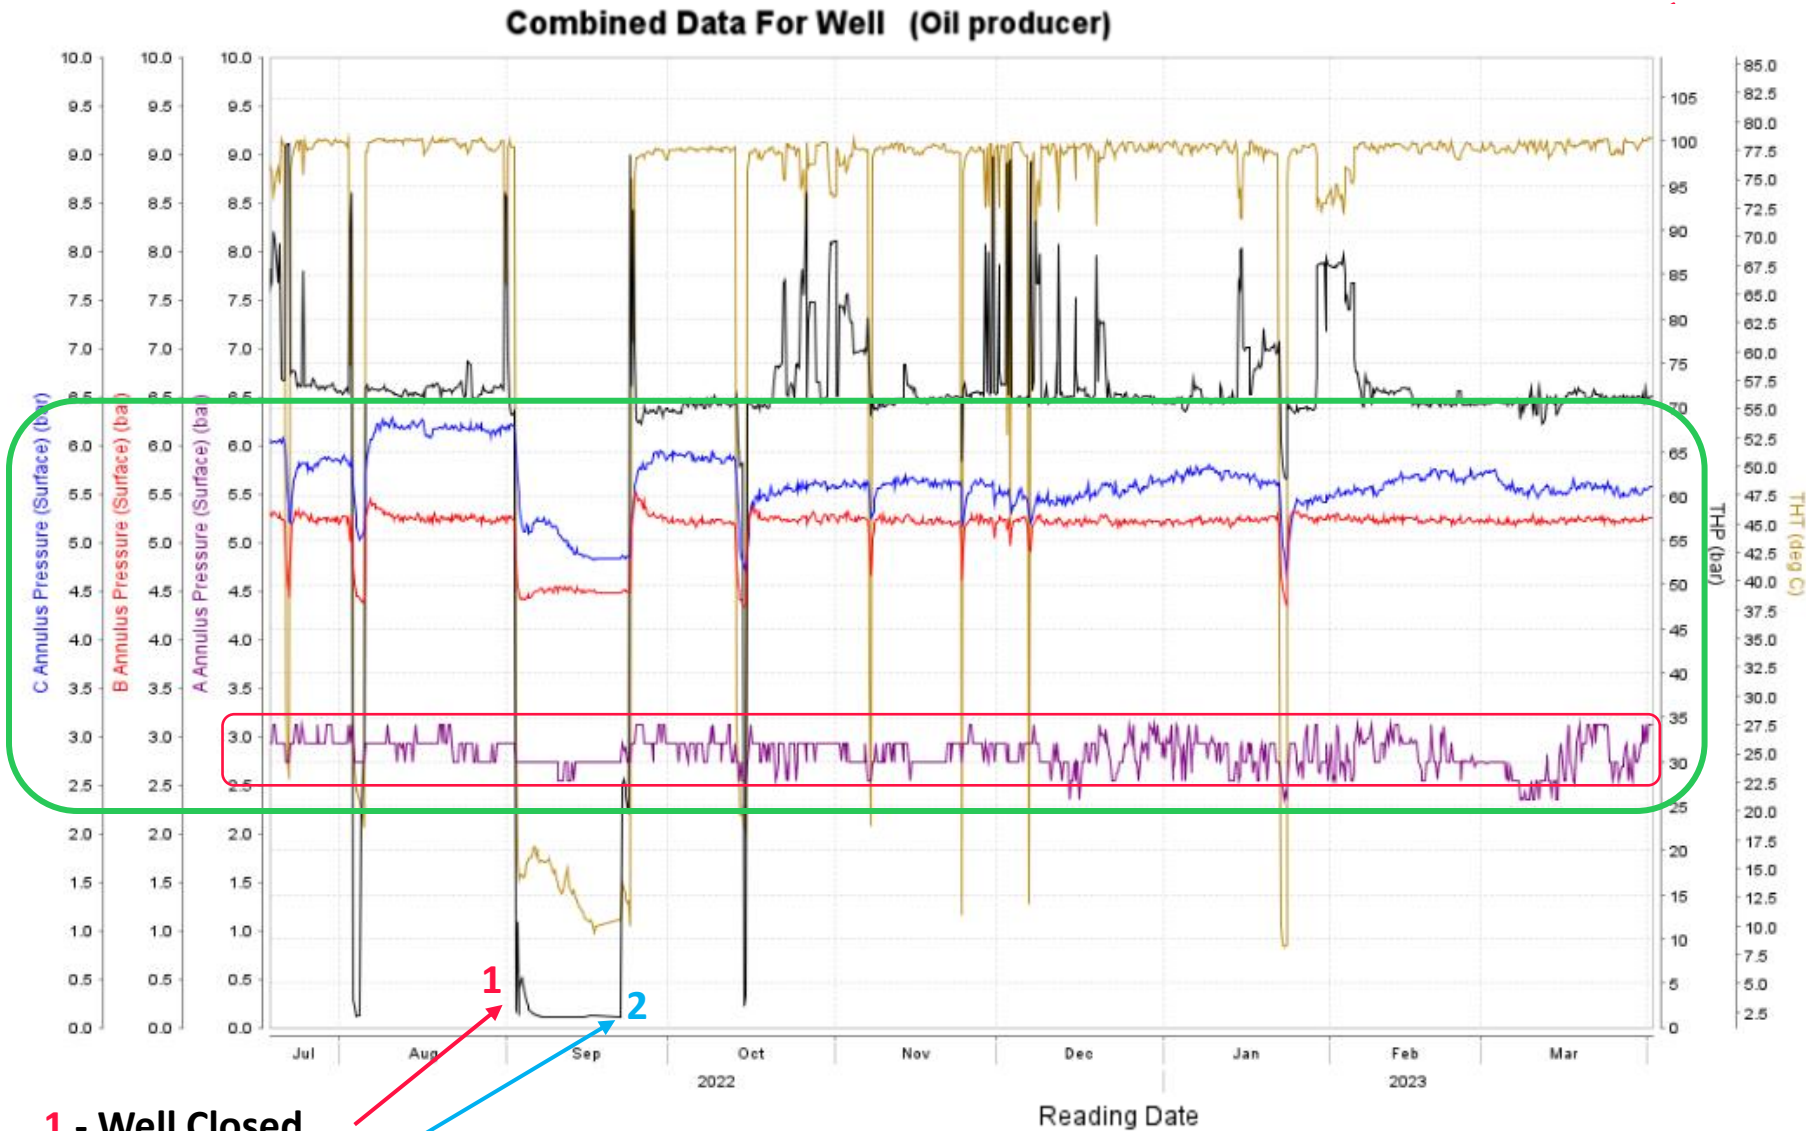
1 - Well Closed
2 - Well Open

- Annulus-A - low and stable pressure for long time.
- All annuli had approx. same pressure.
 - Annulus-A: 3 bar
 - Annulus-B: 5.5 bar
 - Annulus-C: 5.8 bar
- Req. 2 – Monitor pressure development.

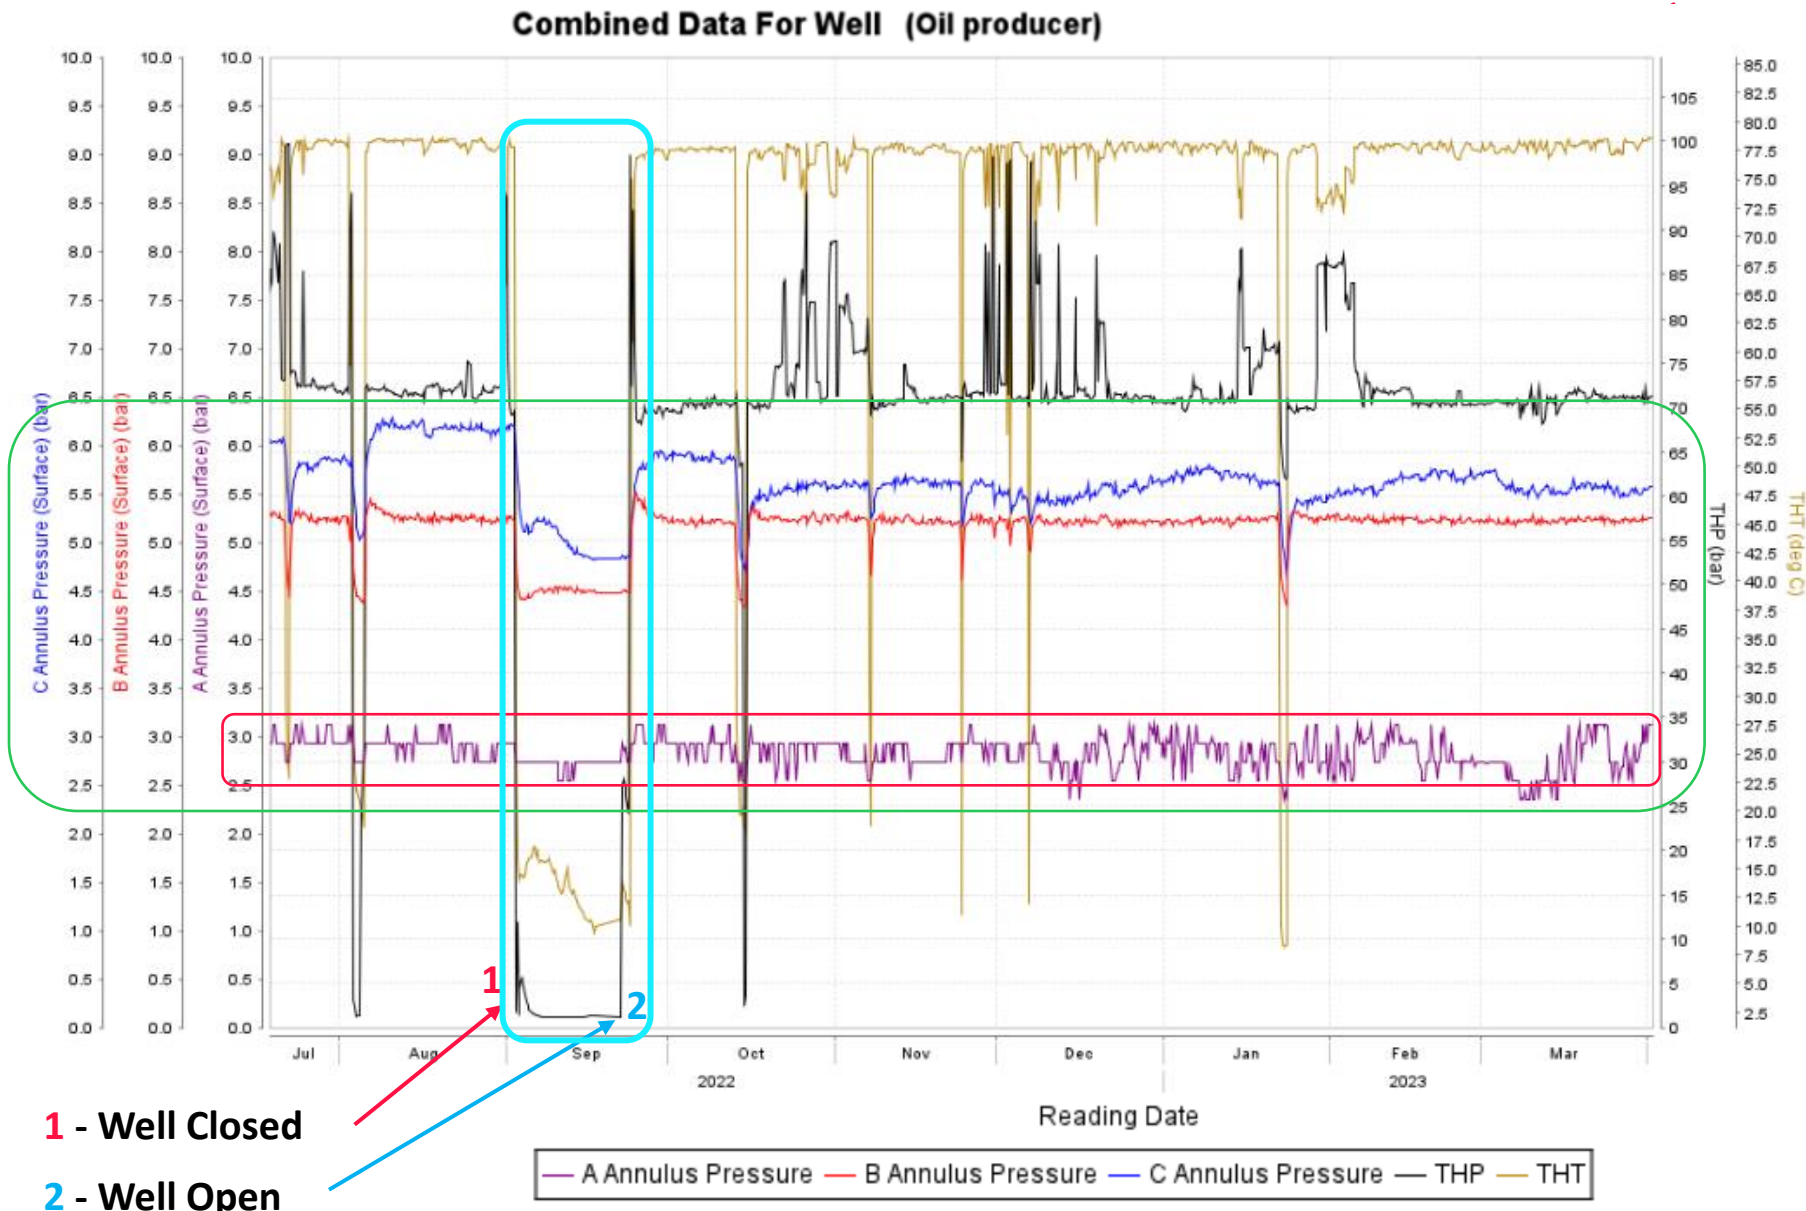
- Annulus-A - low and stable pressure for long time.
- All annuli had approx. same pressure.
- Annulus-A does not react on stop/start of well.
 - Temperature effect.
 - Req. 1 – Liquid filled annuli.

- Further action:
 - Investigate if annulus-A transmitter was defect.
- Result:
 - Annulus-A transmitter functioning.
 - Pressurized annulus-A with nitrogen. Calculated a volume of approx. 20 m³ missing liquid.

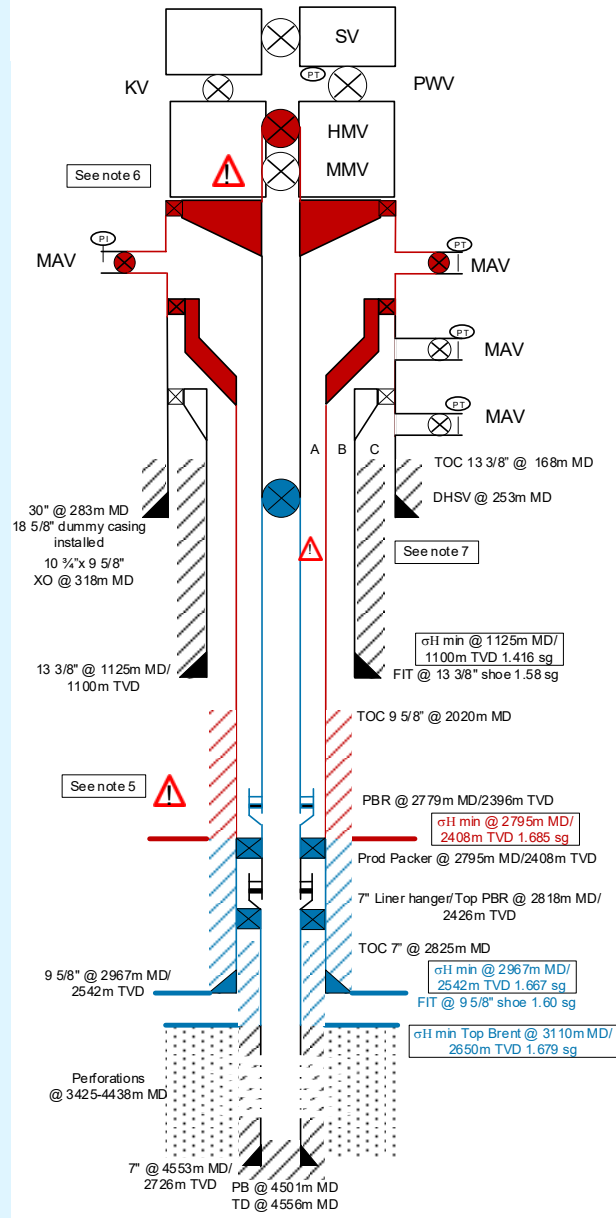
- Suspected leak in primary barrier.
 - Annulus-A to tubing.
- Further action:
 - Liquid fill annulus-A and apply for dispensation to keep well in production.
- Integrity status changed: Yellow

Well barrier elements	WBEAC tables	Verification	Monitoring
PRIMARY			
Formation at Cap rock	51	σ H min 1.679 sg. Method: ref see Note 4.	n/a after initial verification
7" Liner cement	22	Length: 285m MD > Cap rock Method: see Note 1.	n/a after initial verification
7" Liner	2	PT: 280 bar with 1.21 sg (DBR 16.04.1993)	n/a after initial verification
7" Liner hanger packer	43	PT: 280 bar with 1.21 sg (DBR 16.04.1993)	n/a after initial verification
Formation at 9 5/8" casing shoe	55	FIT: 1.60 sg EMW. (DBR 29.03.1993)	n/a after initial verification
9 5/8" Production casing cement (up to prod packer)	22	Length: 172m MD > shoe Method: see Note 2.	n/a after initial verification
9 5/8" Production casing (up to prod packer)	2	PT: 280 bar with 1.52 sg (DBR 27.03.1993)	n/a after initial verification
Production packer	7	PT: 280 bar with 1.06 sg (DBR 21.04.1993)	Continuous pressure monitoring of A-annulus
Production tubing (w/ PBR)	25 (29)	PT: 280 bar with 1.06 sg (DBR 21.04.1993)	Continuous pressure monitoring of A-annulus

DHSV Control line	8	IT: 27 bar (DBR 21.04.1993) PT: 570 bar (DBR 21.04.1993)	Periodic leak testing. AC: Max 3.2 bar/30 min
SECONDARY			
Formation at Prod packer	51	σ H min 1.685 sg. Method: ref see Note 4.	n/a after initial verification
9 5/8" Production casing cement (above packer)	22	Length: 700m MD > packer Method: see Note 2.	n/a after initial verification
10 3/4" x 9 5/8" Production casing (above packer)	2	PT: 280 bar with 1.52 sg (DBR 27.03.1993)	Continuous pressure monitoring of B-annulus
10 3/4" Casing hanger with seal assembly	5	PT: 280 bar with 1.52 sg (DBR 27.03.1993)	Continuous pressure monitoring of B-annulus
Tubing hanger with seals	10	PT: 280 bar with 1.06 sg (DBR 21.04.1993)	Continuous pressure monitoring of A-annulus/ Periodic leak testing
WH/A-annulus access valve	12	PT: xxx bar (DBR xx.xx.1993)	Periodic testing of valve AC: Max 10 % of annulus pressure bar/10 min.
Tubing hanger neck seal	33	PT: 345 bar (FWR 22.04.1993)	Periodic leak testing

X-mas tree connector	33	PT: 345 bar (FWR 22.04.1993)	Periodic leak testing
X-mas tree valves	33	PT: 345 bar (FWR 19.04.1993)	Periodic testing of valve AC: Max 10 % of test pressure bar/10 min.
Notes:

5. PBR part of primary barrier, but status is continuously monitored			
6. Lokkeja i områdene MMV to be replaced/repaired			
7. A-annulus missing ca. 20 m ³ fluid. Equals 50% of annulus volume.			
Well Risk Status Code (marked X): Detailed information in iWIT

A) PBR part of primary barrier			
B) Annulus-A missing ca. 20 m ³ fluid. Challenging to monitor primary barrier. Secondary barrier monitored by annulus-B.			
Closed Dispensations - Still Valid

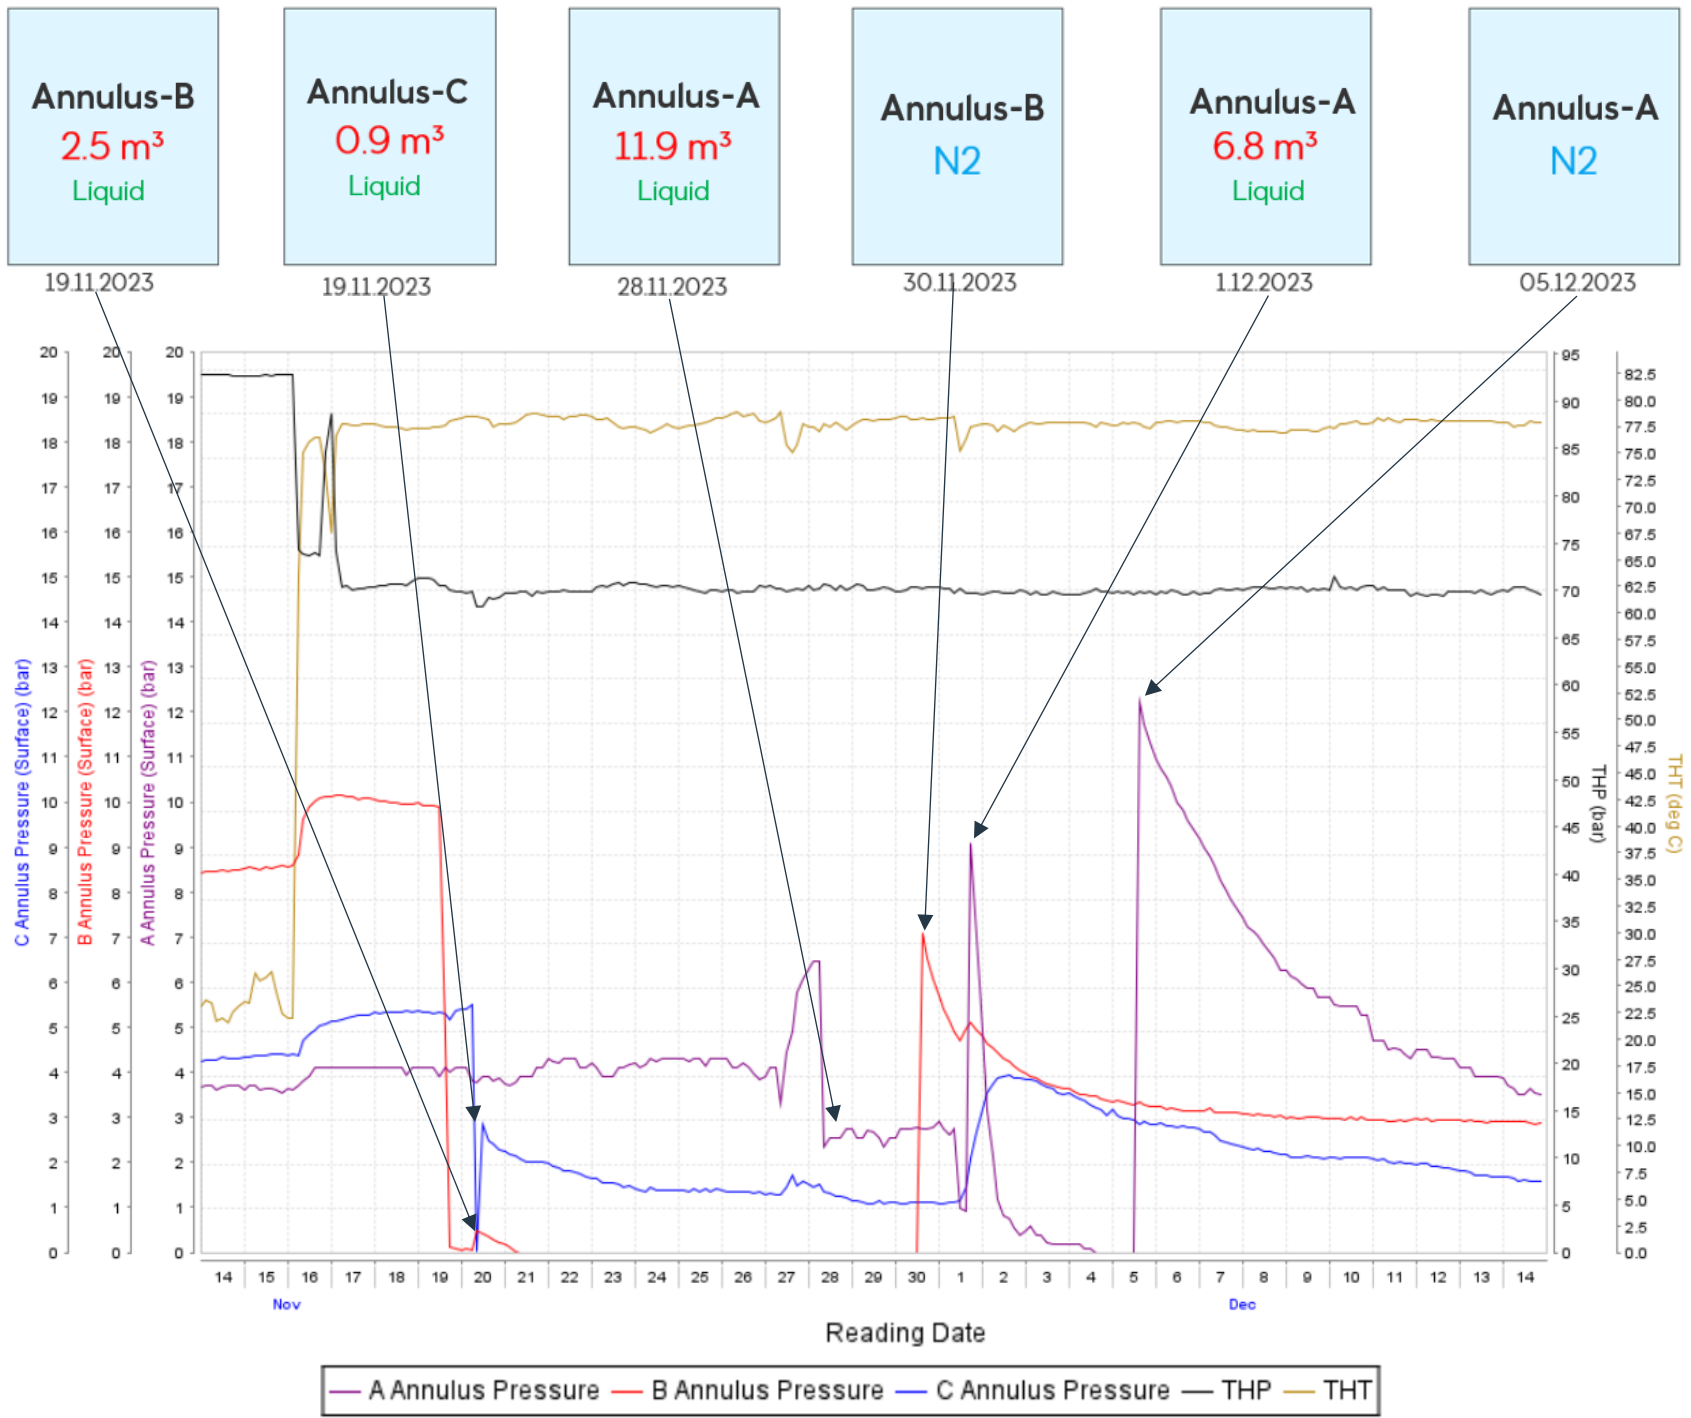
- Annulus-B:
 - Filled 2.5 m³.
 - Cannot hold pressure.
- Annulus-A:
 - Filled 18.7 m³.
 - Cannot hold pressure.

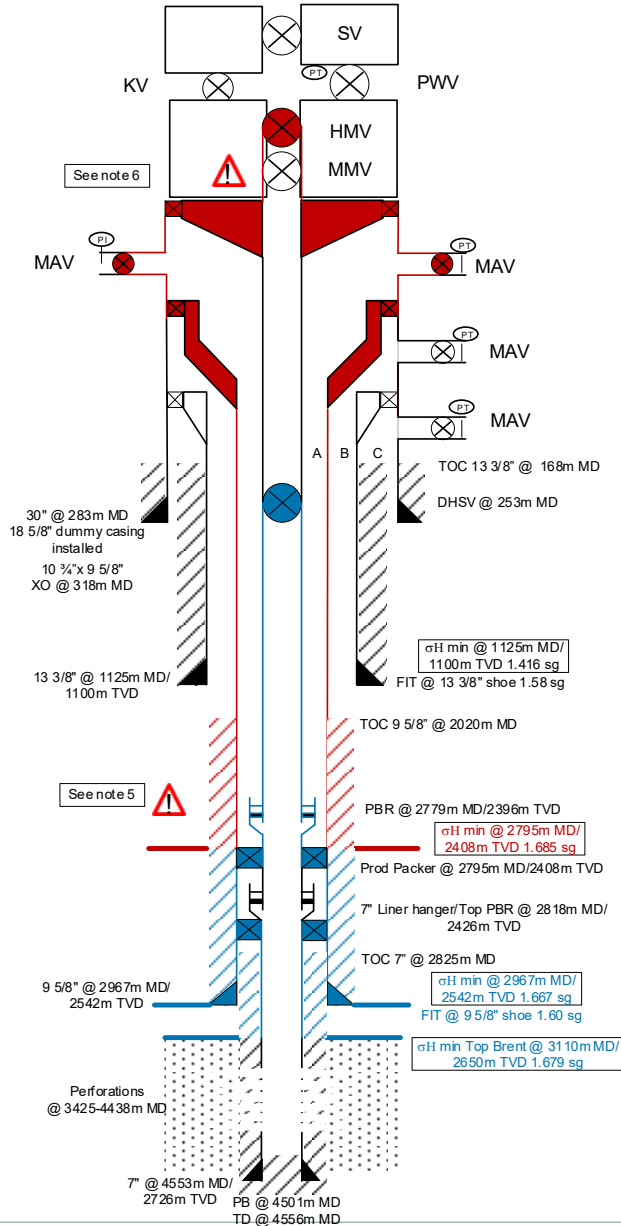
April 2023

Integrity status : Green

- Status April 2023:
 - Green integrity status.
 - No integrity issues to consider.
- Status May 2023:
 - Concluded that 20 m³ liquid is missing in annulus-A.
- Status November/December 2023:
 - Liquid filled annuli.
 - Annulus-A cannot hold pressure, A->T leak?
 - Annulus-B cannot hold pressure, B -> formation leak?

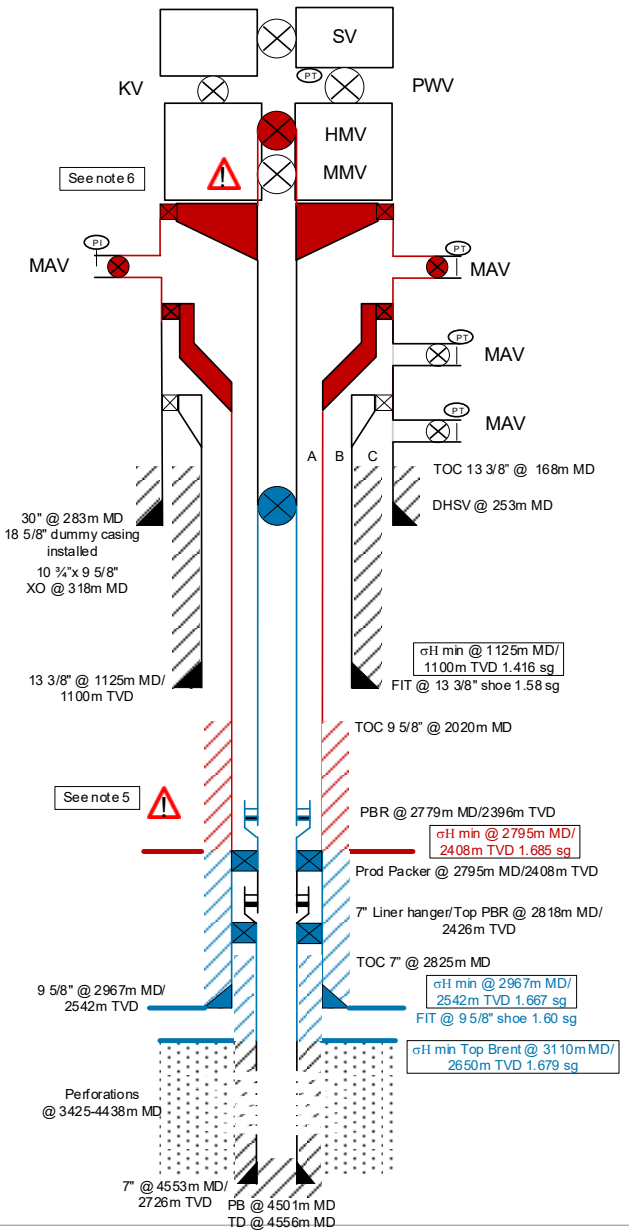
Possible condition

November 2023
Integrity status: Orange

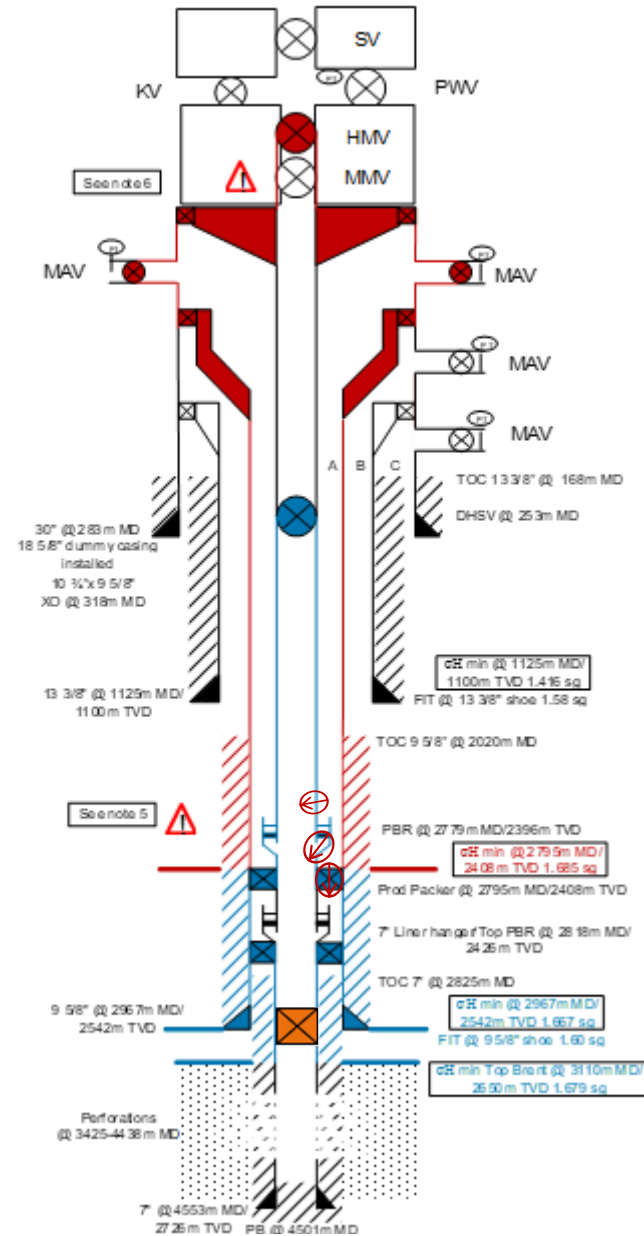
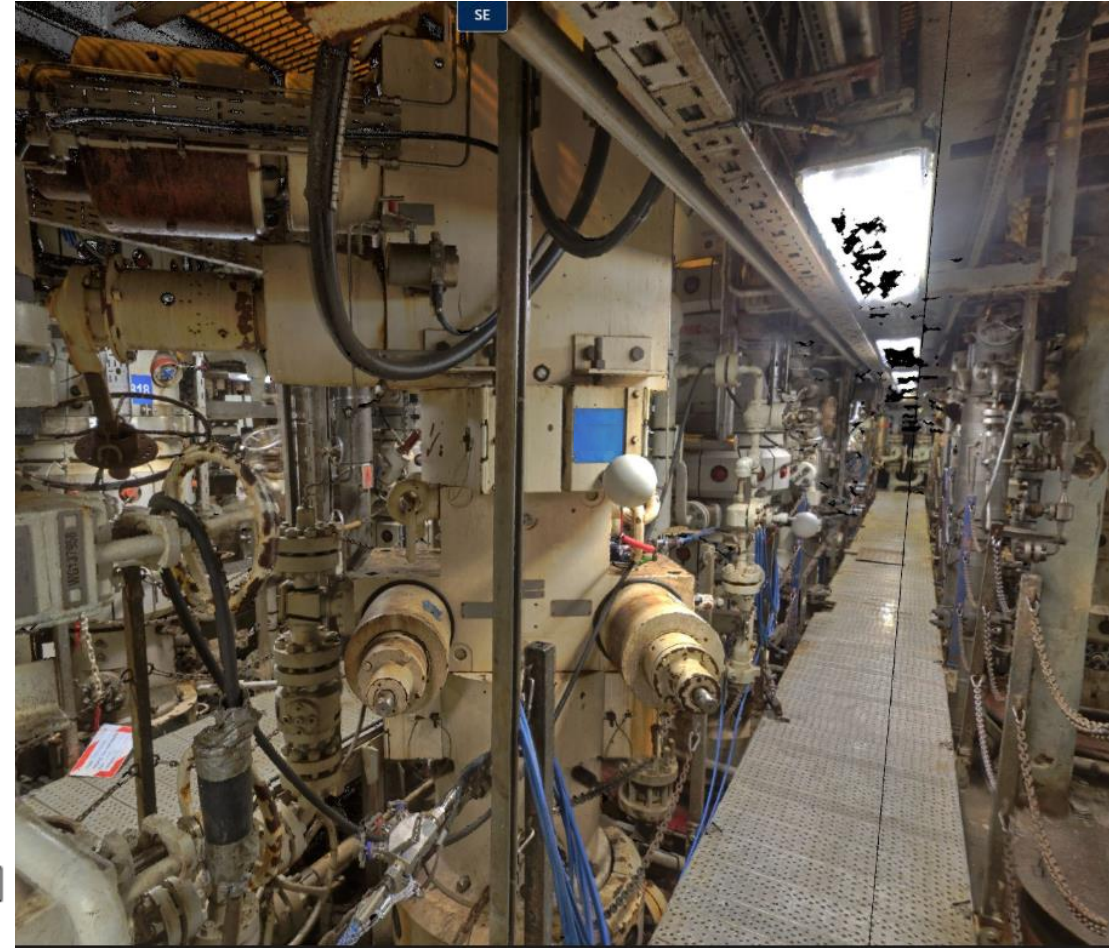
- Task:
 - Verify condition of tubing.
 - Identify leak depth and WBE.
 - Verify condition of secondary barrier.
 - Consider possibility of straddle.

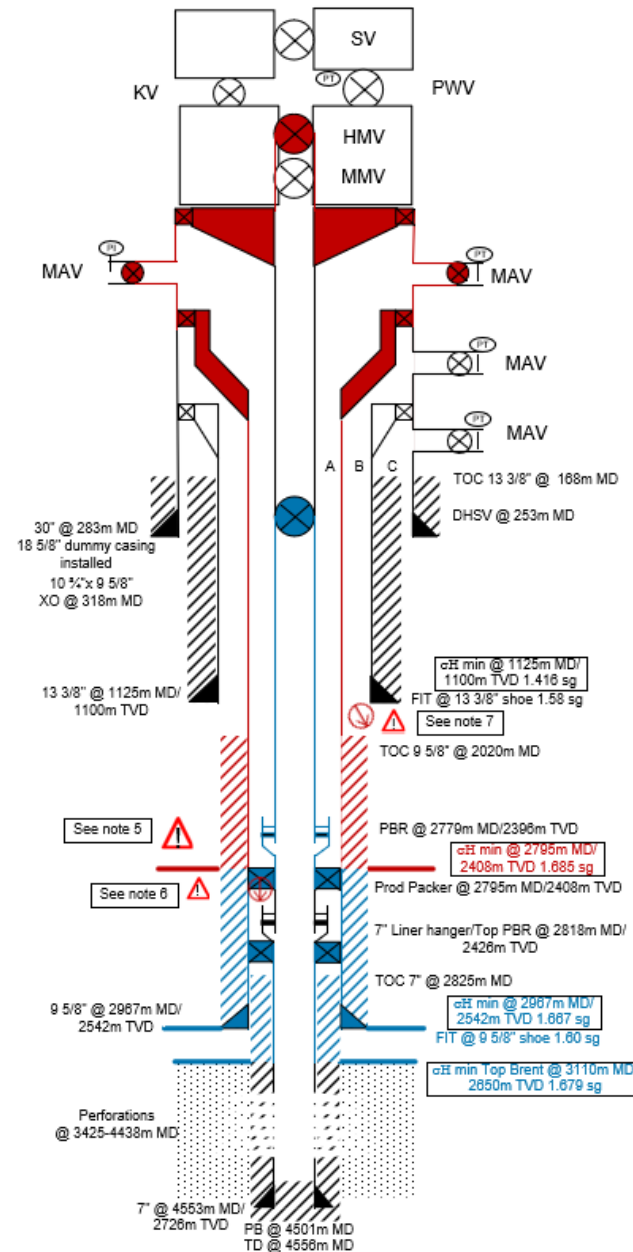
- Findings:
 - Tubing condition– good.
 - Leak in production packer.
 - Small leak.
 - Secondary barrier – intact.
 - No straddle.
 - Yellow integrity status.

- Applied for dispensation to continue operating well.
 - Implemented measures.
 - Well was put on drilling schedule for workover/re-drill.
