# Surface casing corrosion Grane platform wells

Annette Pihl Pettersen, Equinor

## Finding - Severe corrosion on surface casing on two wells

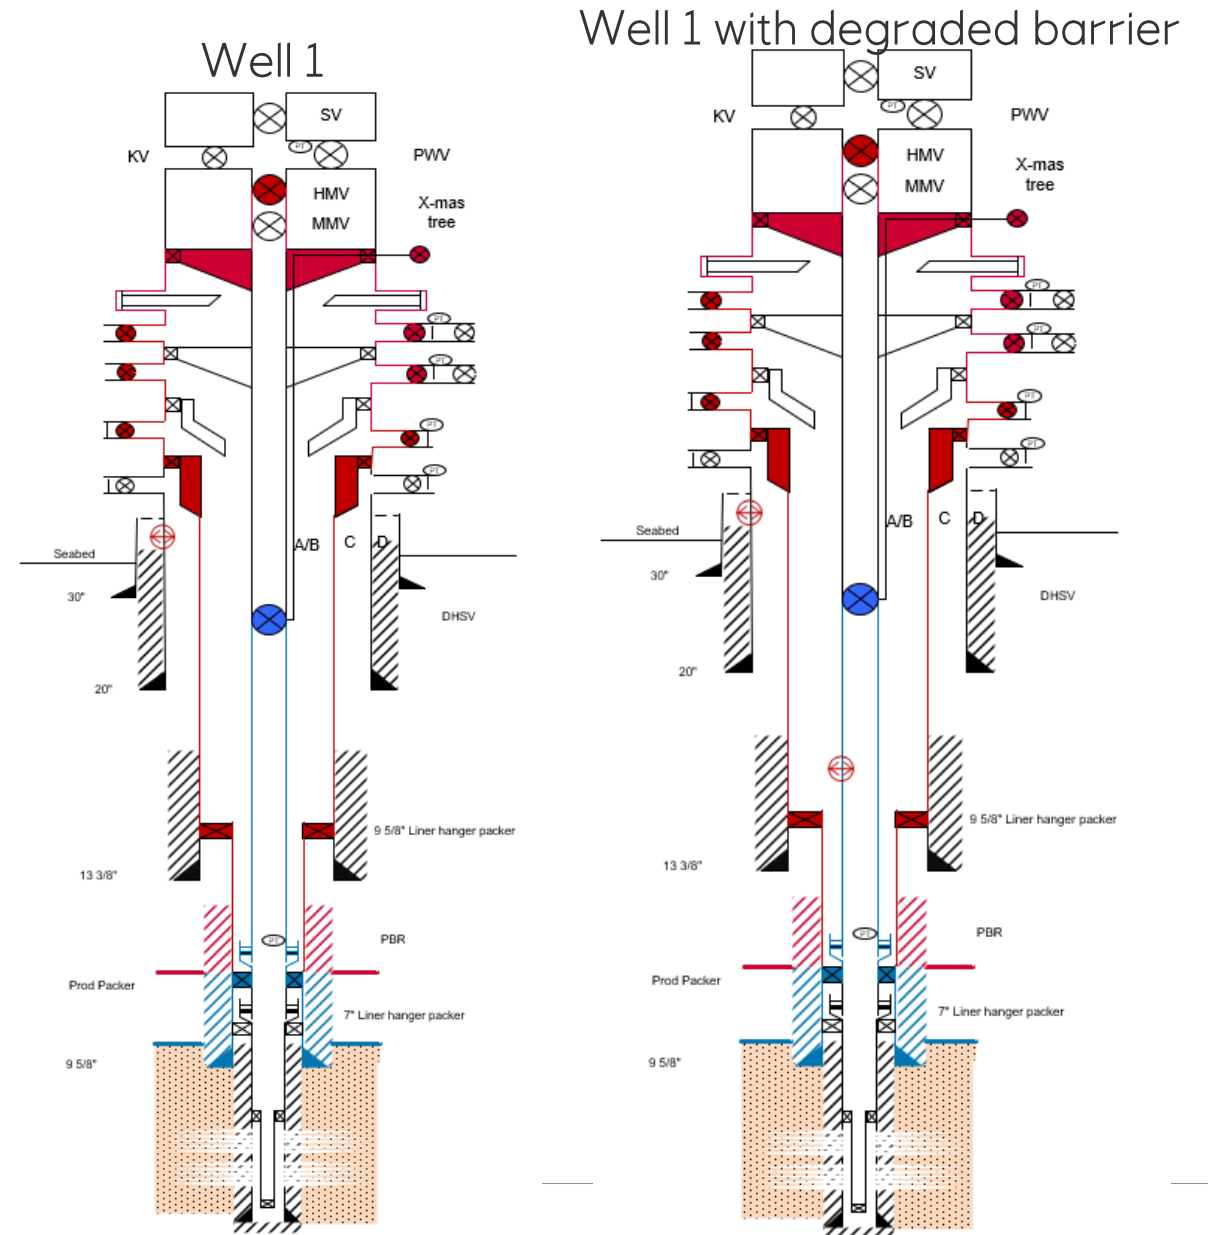
# Group Task: Well 1 Oil producer with severely corroded surface casing WBS against reservoir

Well 1 risks with degraded barrier

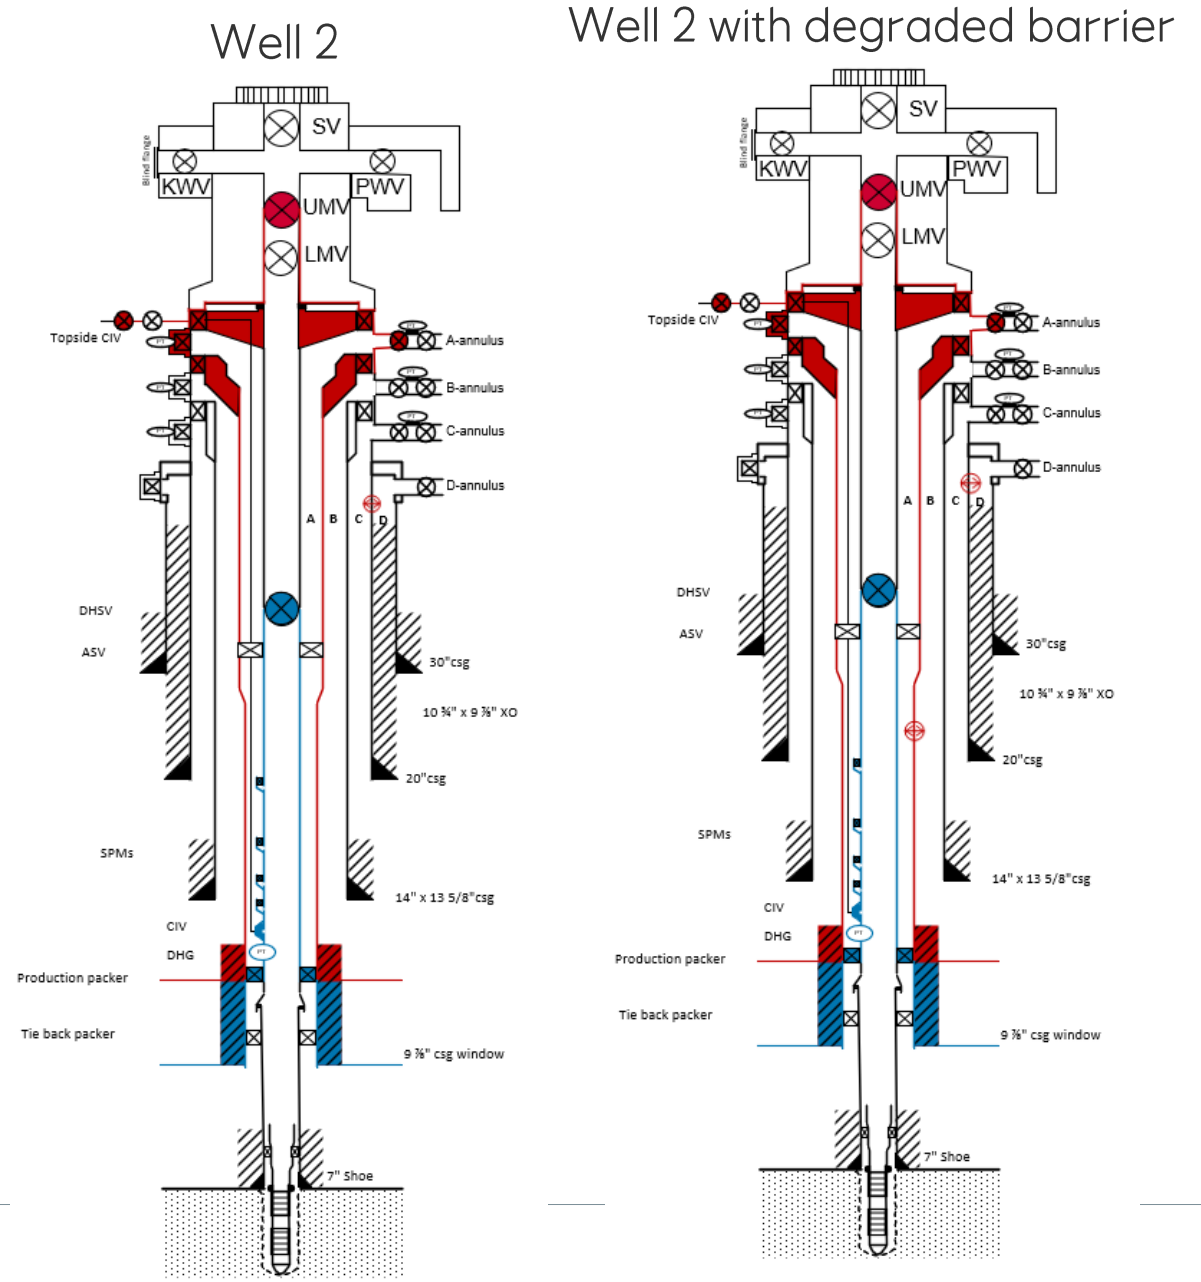
# Group Task: Well 2 Oil producer with severely corroded surface casing WBS against reservoir

Well 2 risks with degraded barrier
